RECREATION GOVERNANCE COMMITTEE MEETING AGENDA

ROCKY VIEW COUNTY
RECREATION GOVERNANCE COMMITTEE
July 27, 2020

During the 2019 inspection, the condition of the 1971 Red Dutton Arena concrete floor slabs could not be entirely determined as the ice was in place, but a major crack was observed in the NE corner of the arena. Even so, the *Capital Renewal Plan* determined that the slab would need to be replaced towards the end of the report timeframe (12 years).

As part of the list of projects identified as a priority for the MSI funds, SPFAS engaged MPE Engineering Ltd. to carry out a review of the slab. The primary recommendation provided by this study (Attachment B) is that SPFAS:

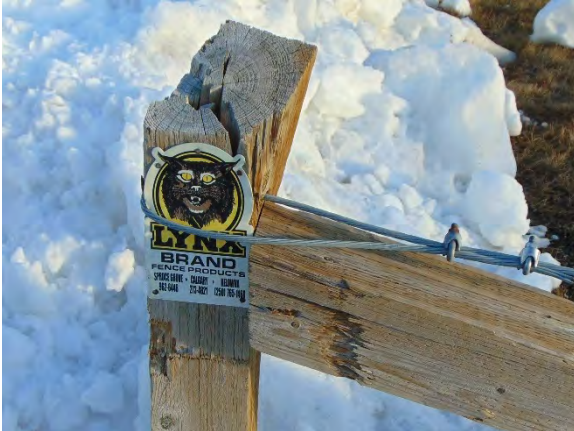
Photo 1
Damaged section of post and cable barrier to the east of the Main Facility

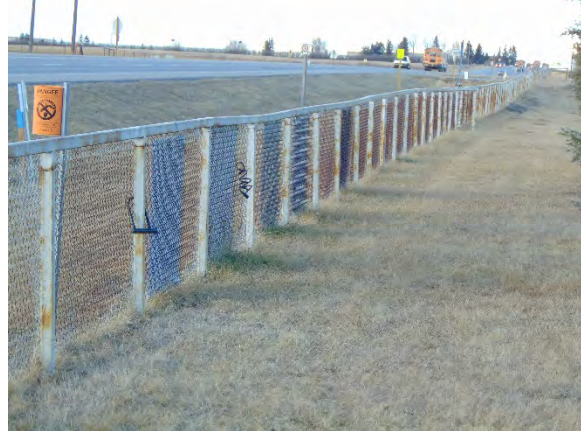
Photo 2
Typical condition of the original part of the fencing along Range Road 33

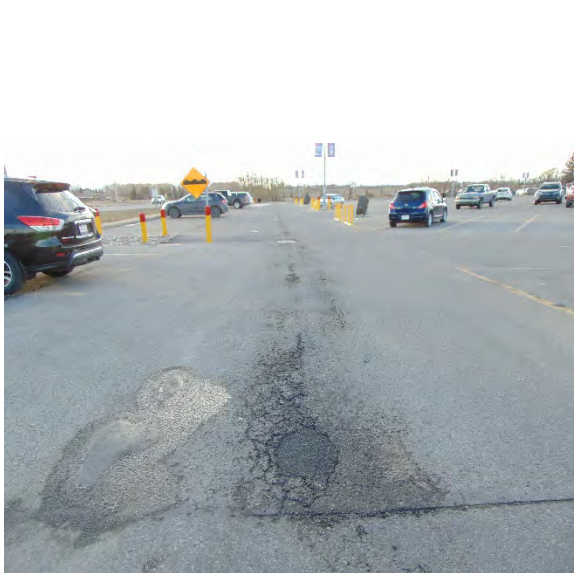
Photo 3
Typical condition of the asphalt paving at the south parking lot

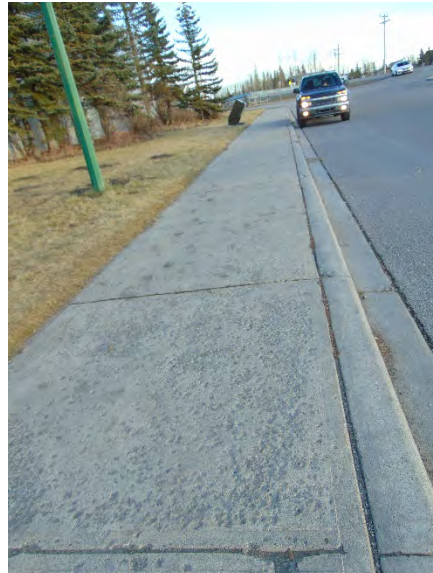
Photo 4
Typical condition of the sidewalk in front of the main facility

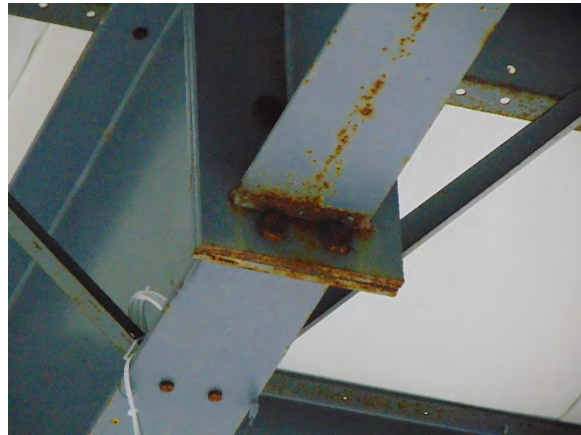
Photo 8
Surface rust and rusty bolt connections and head plates in the Joe Phillips Arena

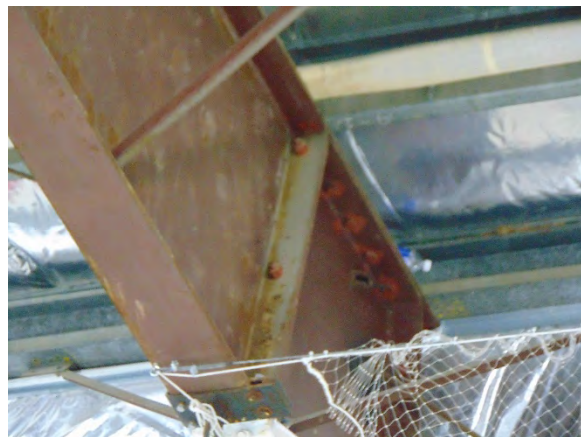
Photo 10
Surface rust and rusty bolt connections on the Red Dutton Arena

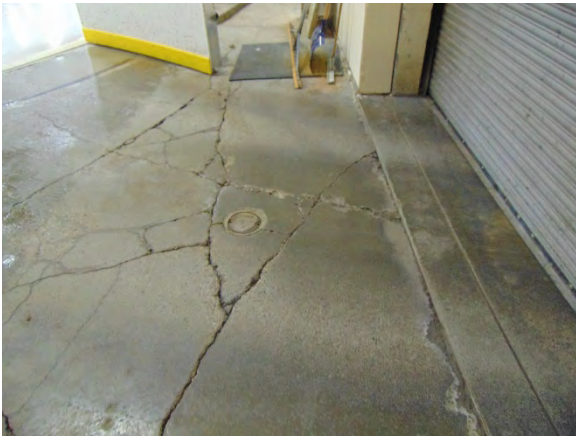
Photo 13
Failed concrete slab section at the Zamboni "driveway" in the Red Dutton Arena

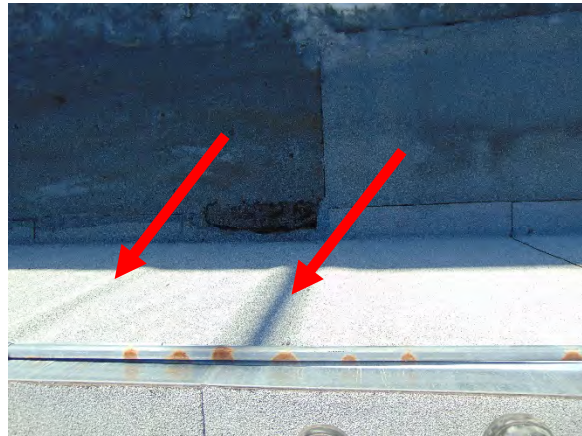
Photo 14
Bubbling SBS membrane at the trench in between Red Dutton and Joe Phillips Arena

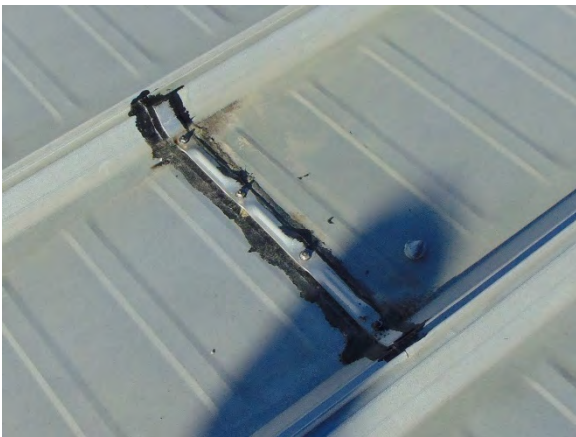
Photo 15
Repaired roof section on the Joe Phillips Arena

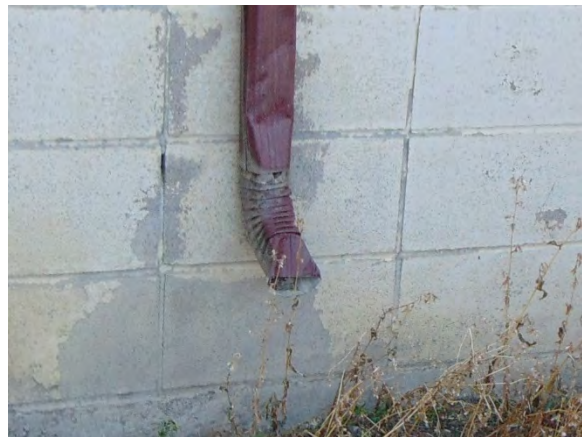
Photo 16
Missing rain water leader along the east side of the Main Facility

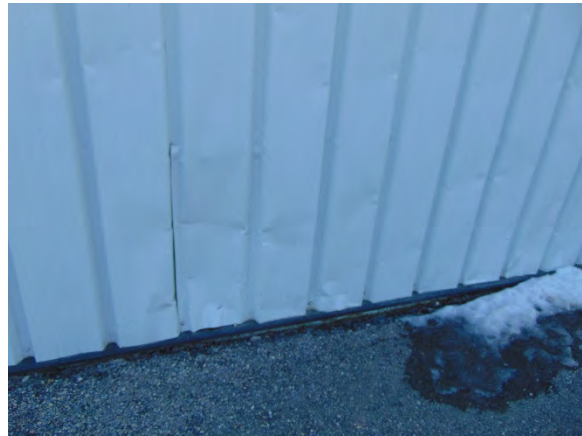
Photo 18
 Impact damage at the exterior metal cladding

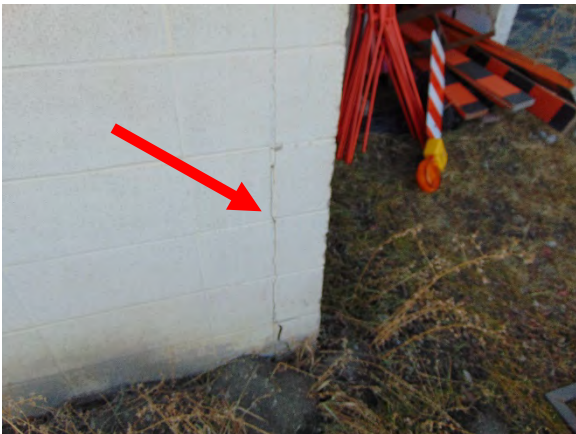
Photo 19
 Cracking observed along the east side of the Main Facility

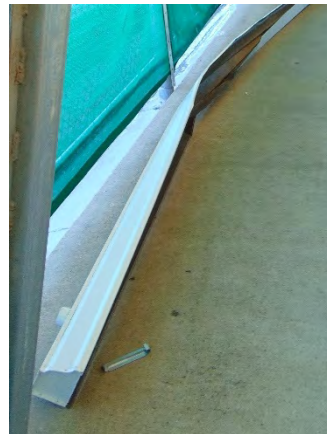
Photo 20
 Damaged rainwater gutter at the Outdoor Rink

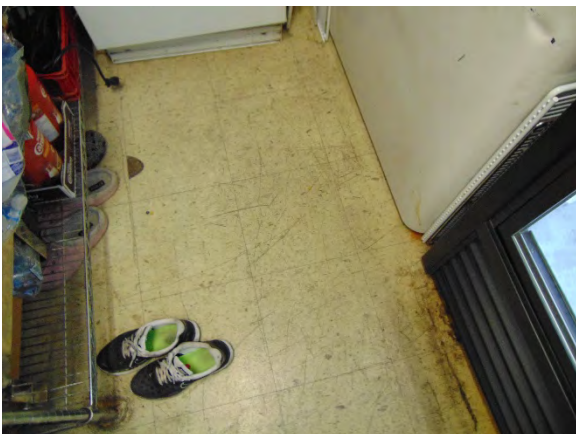
Photo 21
 Worn VCT flooring in the concession pantry

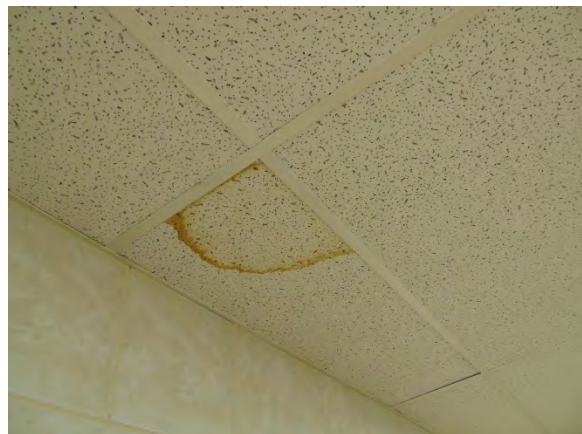
Photo 22
 Stained ceiling tile in the Shane Homes Curling Rink washrooms

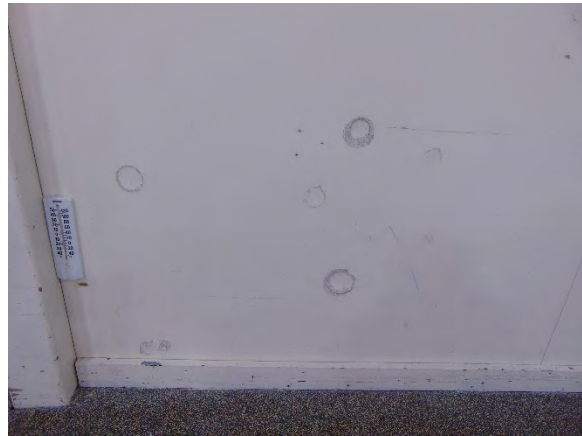
Photo 24
 Impact damages in the Shane Homes Curling Rink's plywood siding.

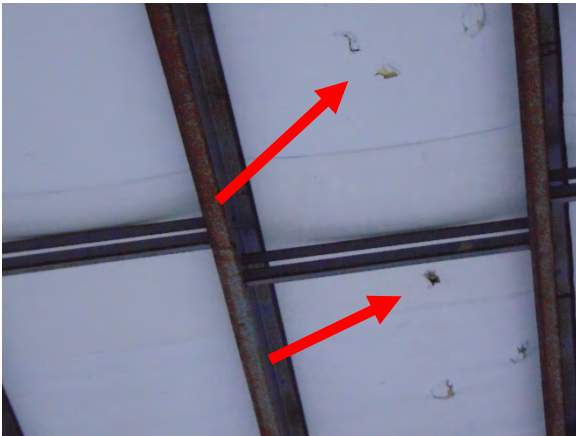
Photo 25
 Impact damages at the Joe Phillips Arena's roof insulation

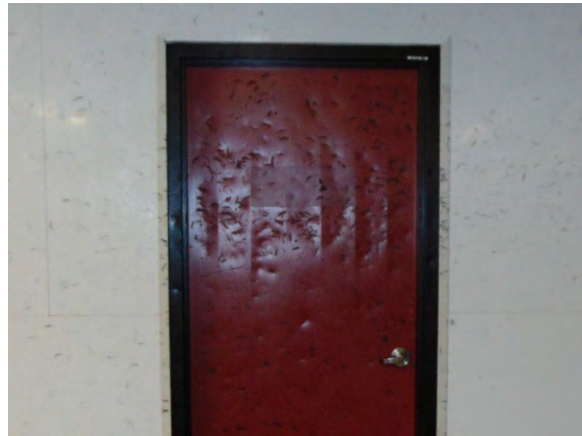
Photo 26
 Impact damages at the door to the electrical room near the dry training area

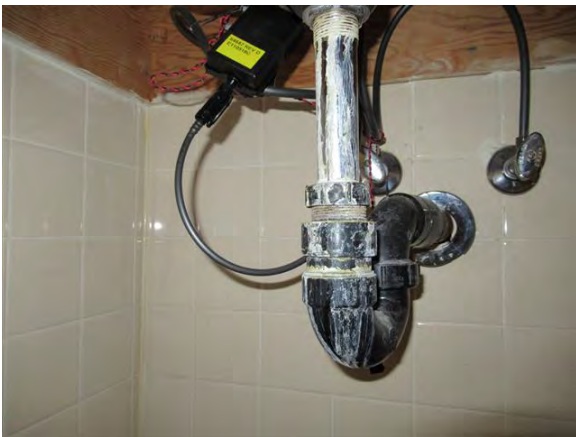
Photo 27
 View of previous water leak under lavatory in one of the change rooms

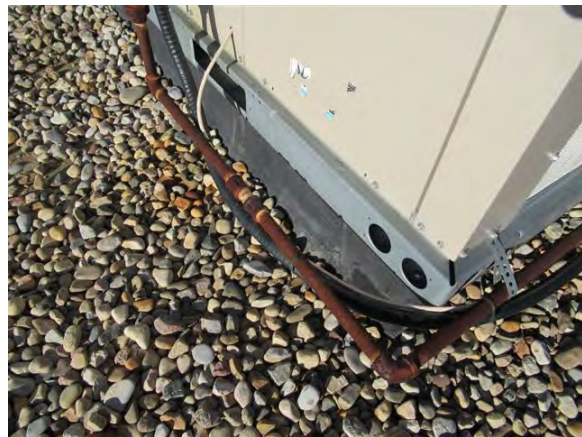
Photo 28
 Deteriorated natural gas piping on the roof of the Curling Centre serving a roof top unit

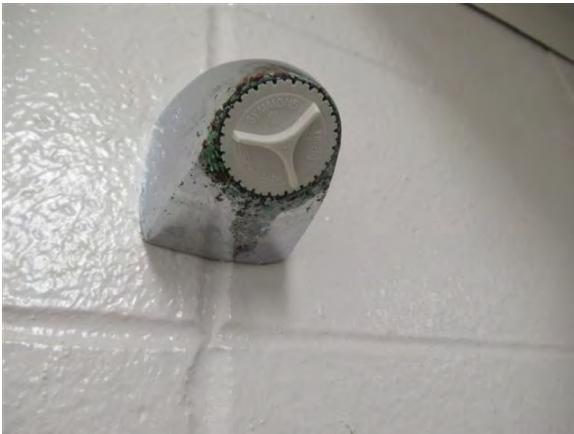
Photo 29

View of corroding and mineral build-up of older style shower head

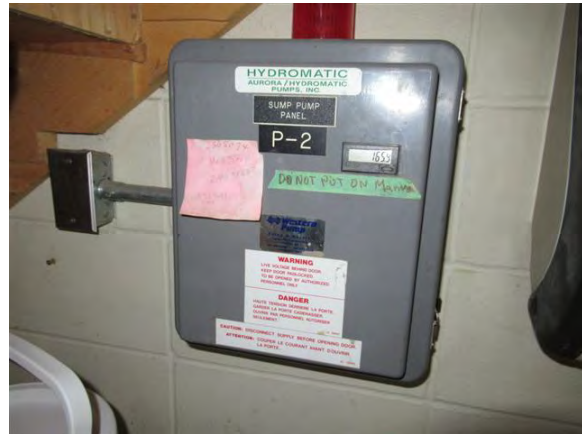
Photo 30

View of sump pump panel P-2 which is no longer connected to the pump

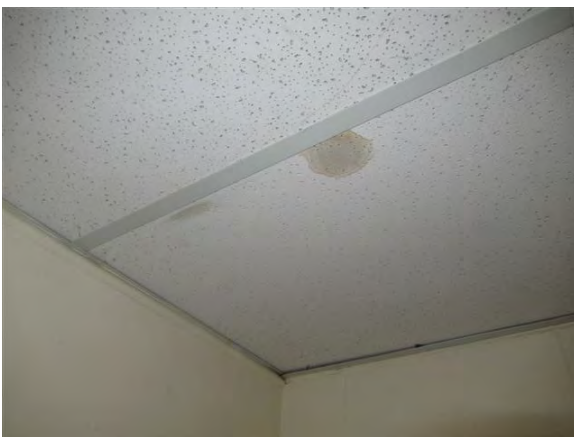
Photo 33

View of previous leak from the ceiling mounted glycol fed heater

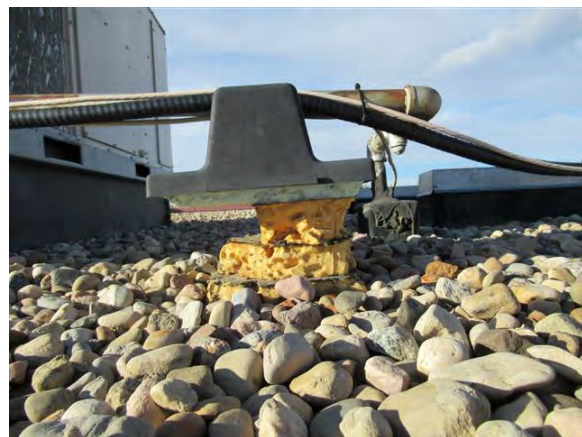
Photo 34

Poor support of natural gas piping on the roof of the Curling Centre

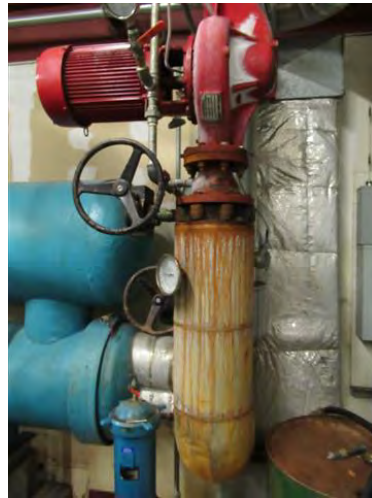
Photo 36

Evidence of previous leak from the chiller pump

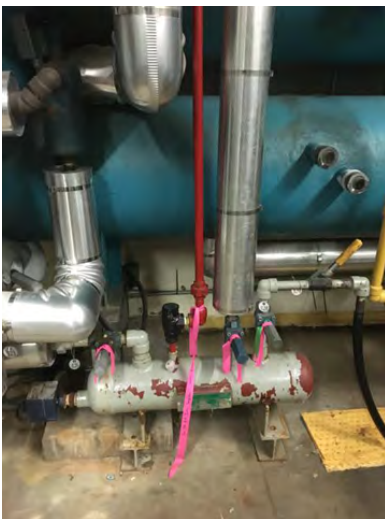
Photo 37

View of oil pot showing corrosion

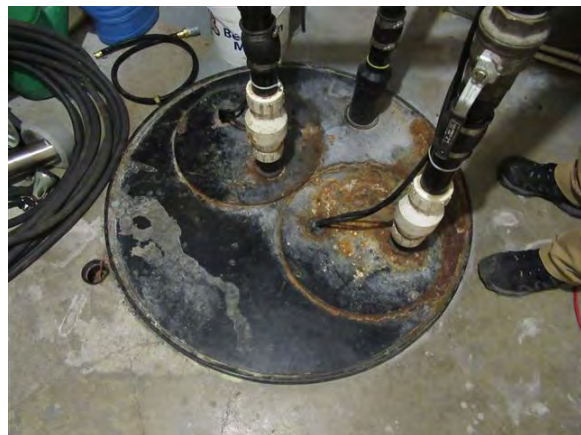
Photo 38

View of corroded cover on sump pump lift station in the Curling Centre mechanical room

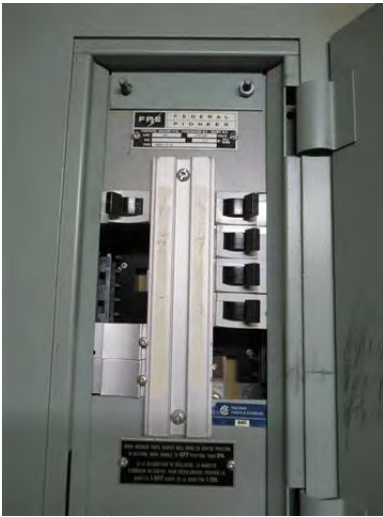
Photo 39
View of missing cover plates on panelboard in the Red Dutton Mechanical Room

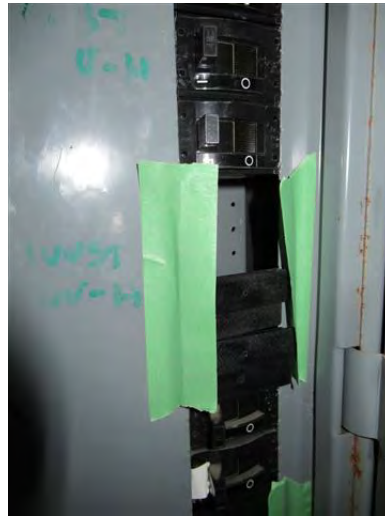
Photo 40
View of another missing cover plate on circuit breaker in Refrigeration Room

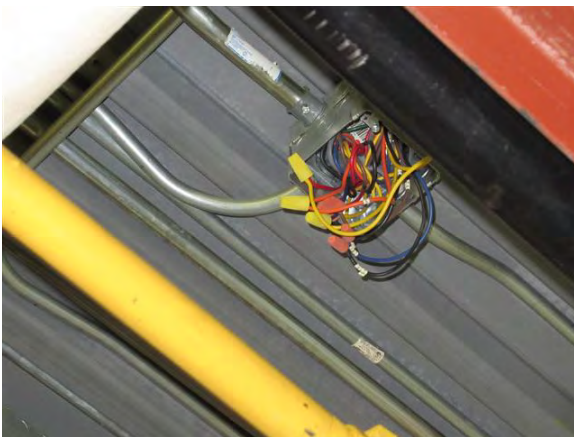
Photo 41
Missing cover plate on junction box in second floor mechanical room

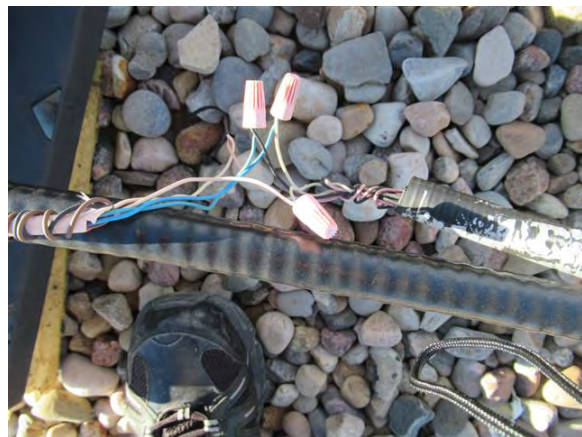
Photo 42
Exposed controls wiring on the roof of the Curling Centre

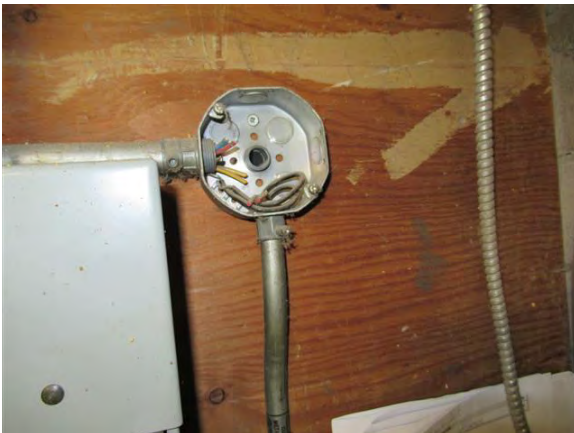
Photo 43
Missing cover plate on junction box in Red Dutton Mechanical Room

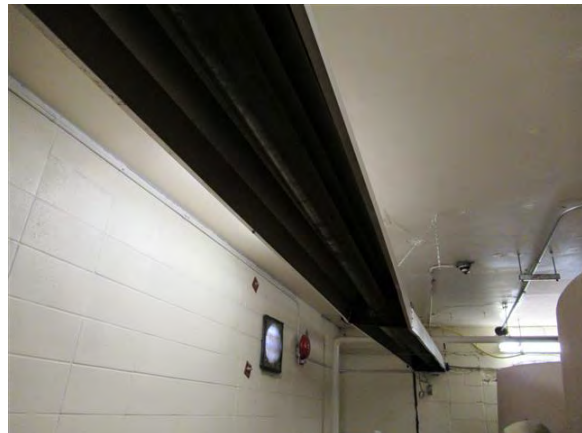
Photo 44
Damaged radiant heater in the old Curling Club refrigeration room

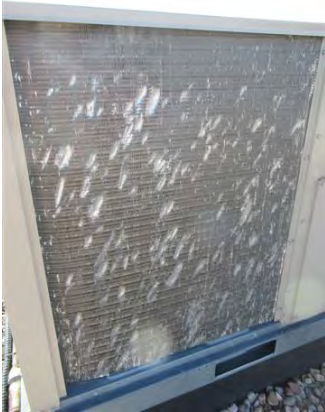
Photo 45

Hail damage to the condenser on one of the Roof Top Units serving the Curling Centre

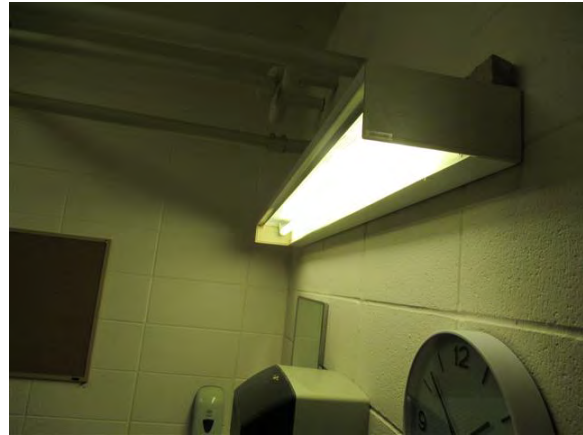
Photo 46

Missing lens cover on light fixture in one of the officials dressing rooms

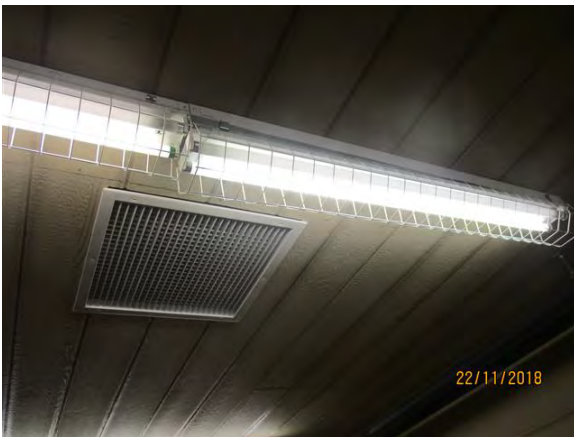
Photo 47

Loose lens cover on light fixture in the Field House

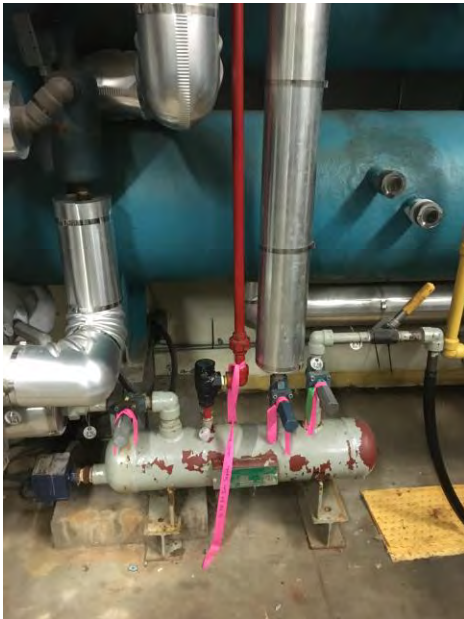
11. Oil pot showing corrosion and vapor relief valve in liquid service

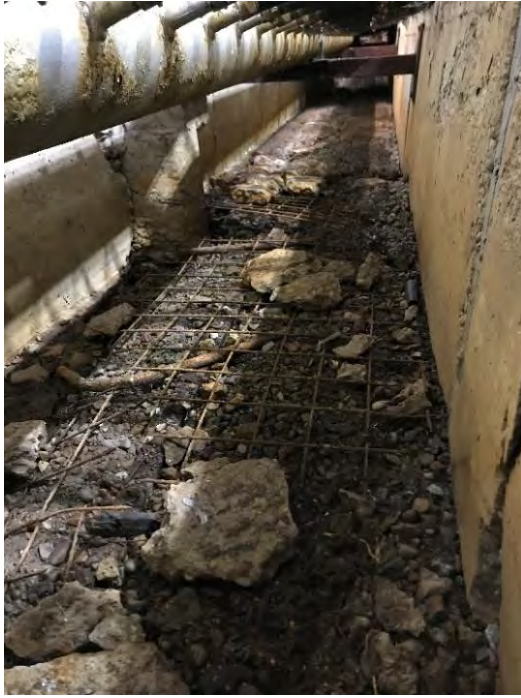
As there was some settlement of the slab measured along the west end of the arena, there is evidence that groundwater may also be contributing to the frost heave of the slab, but this was a much smaller amount of movement. The groundwater level below the Red Dutton Arena was measured between 2.20 m and 1.56m from the finished floor placing it below the anticipated frost penetrations. This is likely because the header trench, with its deteriorated floor, acts as a sump and drains the area and also lowers the general water table.

Photo 1. Red Dutton header trench floor condition

Plan to replace the Red Dutton Arena slab and header trench, including the installation of a new gravel base, sub-slab weeping tile system and sub-slab heating system as soon as fiscally possible; and that

To prevent the frost action from heaving the rink slab, the floor of the header trench will need to be replaced and the walls repaired to create a watertight trench as soon as fiscally possible. But as the header for the slab refrigeration system is located in the trench, replacement of the floor and repair of the walls is nearly impossible without disturbing this piping. Additionally, the cracking caused by the frost heave in the slab has created significant damage to the rink slab, which will only continue to get worse. The slab has been in place for 50 years and has reached its service life and should also be replaced at the same time as the header trench. The condition and service life of the refrigeration system and piping was not assessed as part of this review and considering the condition of the concrete a review of the system is not warranted.

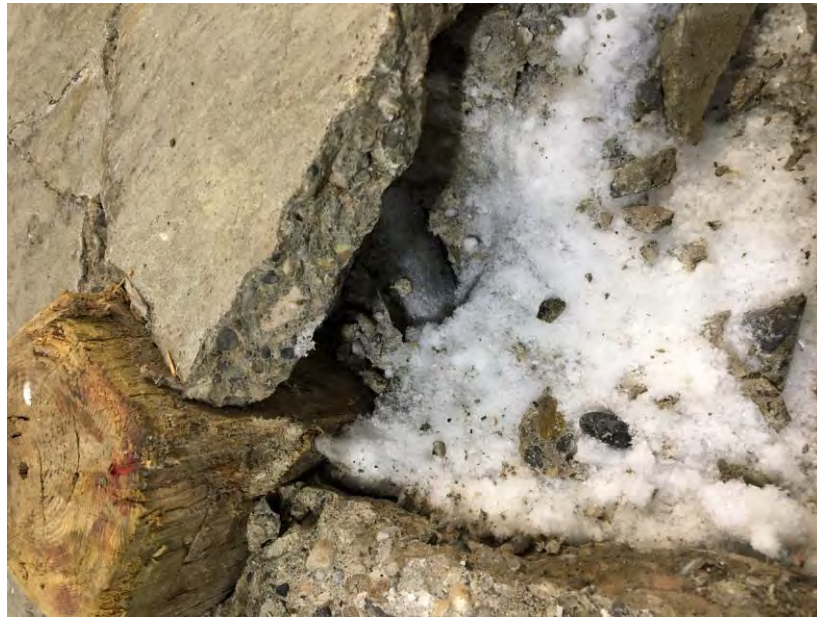
Photo 3. Slab condition and ice formation under slab adjacent to Red Dutton Arena

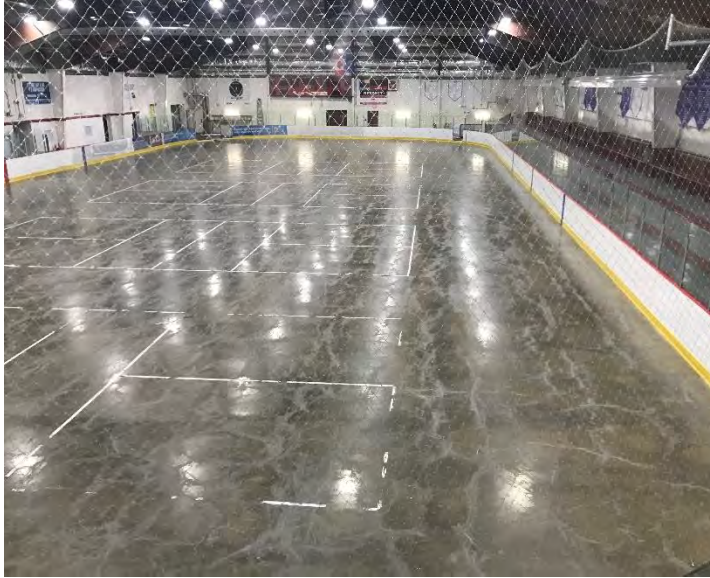
The Joe Phillips slab has visible cracking throughout the slab and from discussion from staff it was reported that movement of the slab is not isolated to a specific area. From the slab surveys conducted, the rink slab's elevation is higher by between 0.5 cm and 1.0 cm throughout the west end of the rink. The east end of the rink only had a couple of isolated spots that were measured 0.5 cm higher from the initial survey. This upward movement of the slab after the ice was removed supports the conclusion from the 2014 MPE report, suggesting the slab movement was primarily due to expansive soils and not frost heave as it would be expected the slab to lower as the ground thaws. From March to June the groundwater level steadily increased below the Joe Phillips slab to a maximum height of 0.64 m below the slab. This increase in groundwater level is likely a result of the sump pump not operating in the manhole that collects the flow from the exterior weeping tile and French drain system. As the overland flow filled the French drain and was not pumped away it could then saturate the ground and increase the groundwater level. Once the pump was repaired and operational again the measured groundwater level started to drop and in July was measured at 0.85 m. Frost heave is not believed to be a significant contributor to the slab movement as the Joe Phillips Arena does have an operational sub-slab heating system and this should prevent the ground from freezing below the rink. Scoping of the weeping tile system in the winter after ice has been in place for an extended period of time to see if the standing water is frozen would determine if the sub-slab heating system is effective in preventing the ground from freezing.

Photo 4. Overview of Joe Phillips Slab

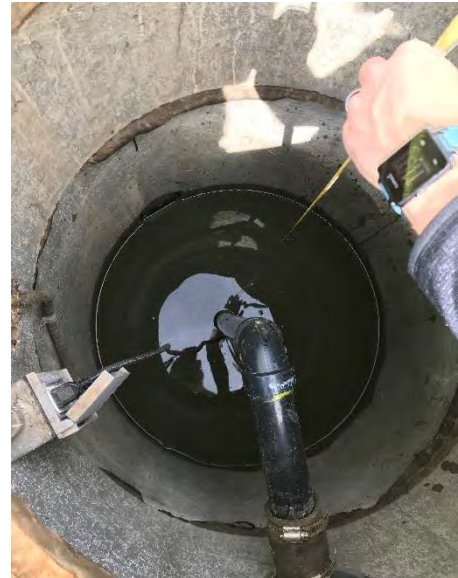
Scoping of the sub-slab weeping tile found that there were sections that were crushed, sections that had sags and sections of the laterals that run the length of the rink that are back graded. All of these issues combined, prevent the weeping tile from effectively draining the water from under the Joe Phillips slab and reducing the groundwater elevation. The high groundwater level around the Joe Phillips Arena is likely the cause of the stuck door on the west side where frost heave lifts the grade beam causing the door to be pinched. A piezometer installed on the north west side of the building would allow for the monitoring of the ground water in the area to assess the effectiveness of the french drain and sub-slab weeping tile in lowering the ground water.

Photo 5. Water level in French drain collector sump manhole with failed pump

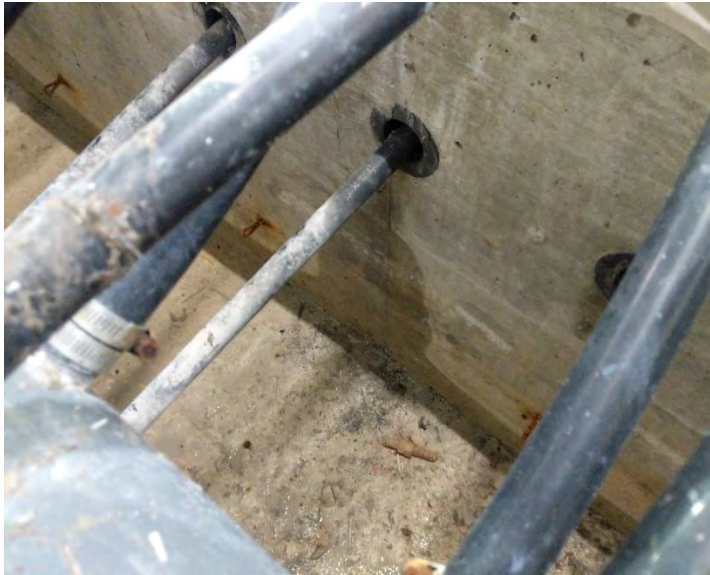
Photo 6. Water seeping into header trench from under Joe Phillips slab through piping holes
