SUBJECT: Change of MSI-Funded Project Scope at Springbank Park For All Seasons

CAPITAL RENEWAL PLAN

SPRINGBANK PARK FOR ALL SEASONS

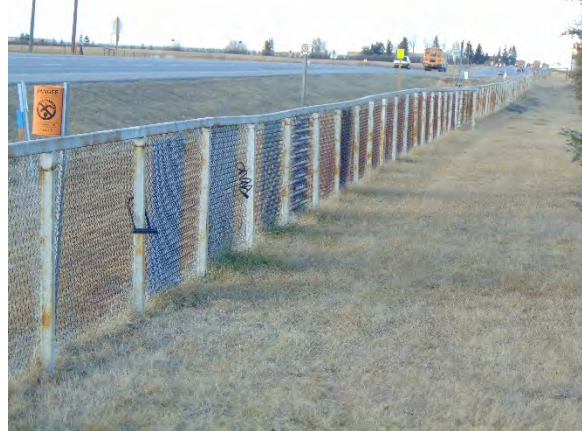
Photo 2

Typical condition of the original part of the fencing along Range Road 33

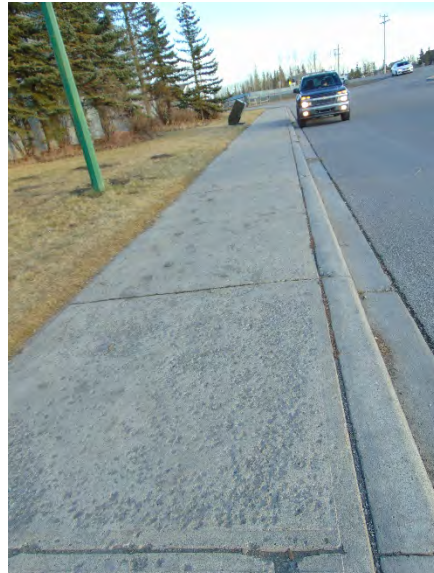
Photo 4

Typical condition of the sidewalk in front of the main facility

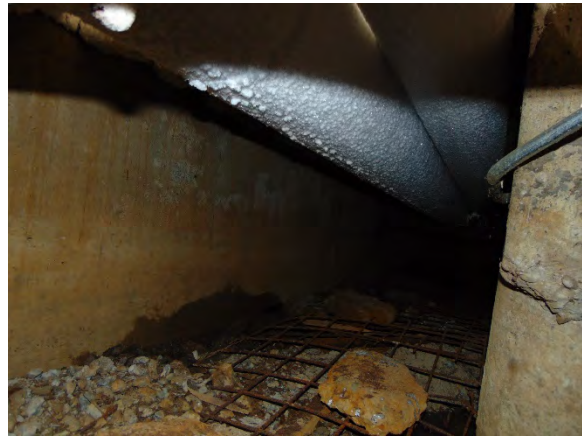
Photo 12
Exposed rebar and debris in the Red Dutton Arena header trench

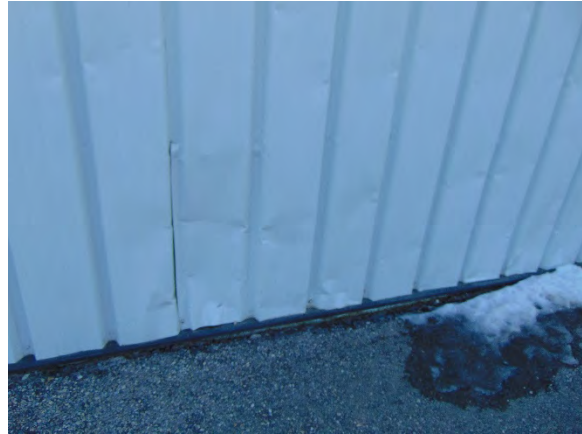
Photo 18
Impact damage at the exterior metal cladding

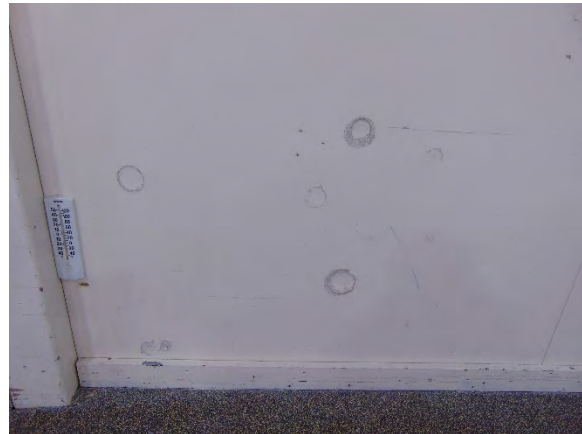
Photo 24
Impact damages in the Shane Homes Curling Rink's plywood siding.

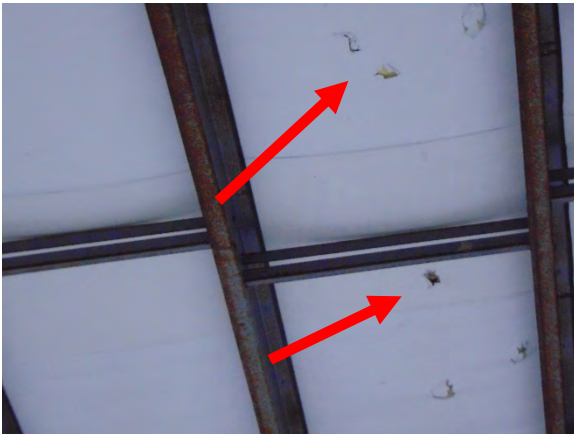
Photo 25
Impact damages at the Joe Phillips Arena's roof insulation

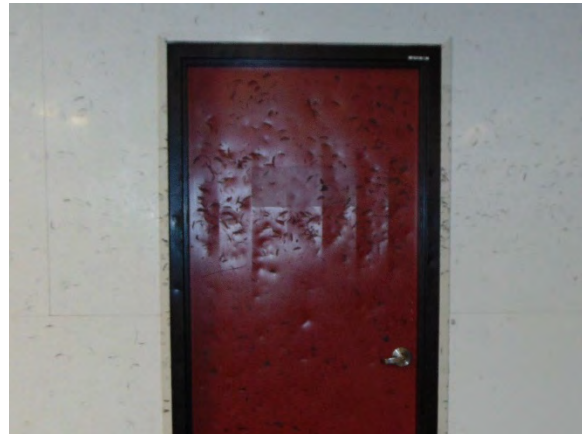
Photo 26
Impact damages at the door to the electrical room near the dry training area

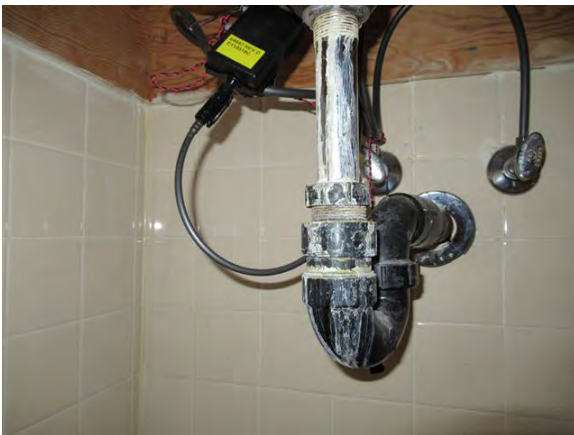
Photo 27
View of previous water leak under lavatory in one of the change rooms

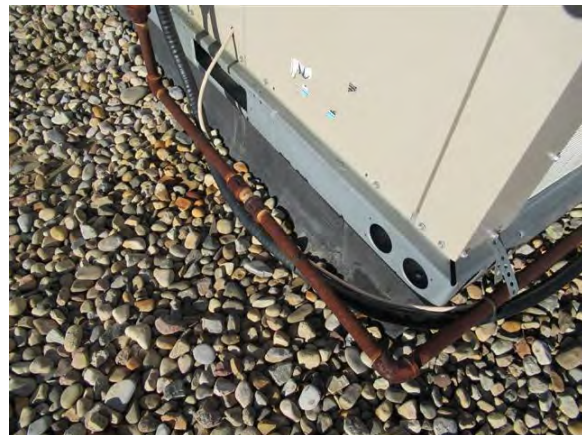
Photo 28
Deteriorated natural gas piping on the roof of the Curling Centre serving a roof top unit

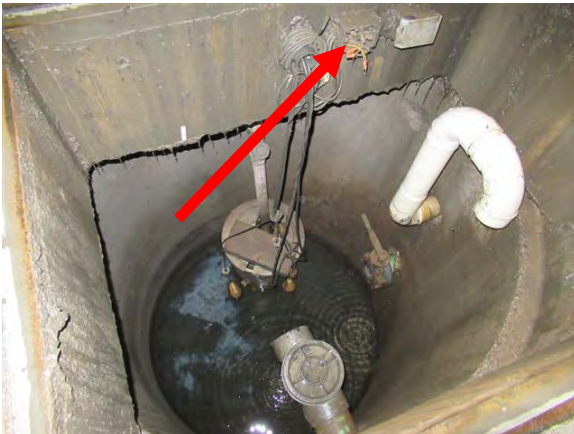
Photo 31

Sump pump P-2 showing exposed electrical wiring

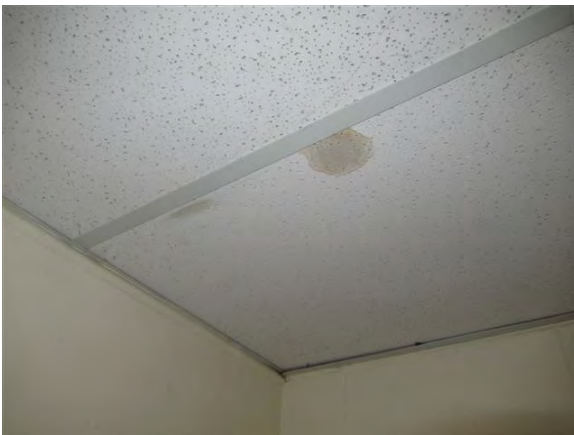
Photo 33

View of previous leak from the ceiling mounted glycol fed heater

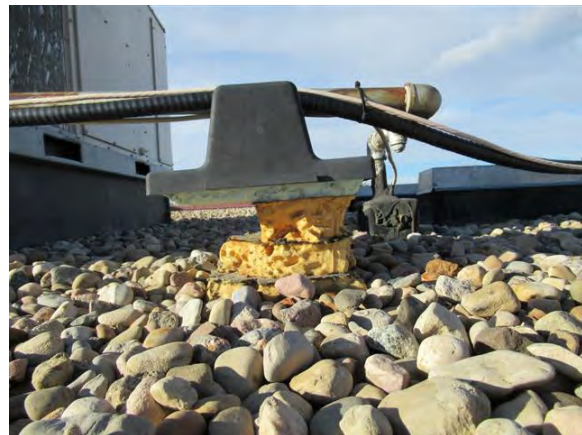
Photo 34

Poor support of natural gas piping on the roof of the Curling Centre

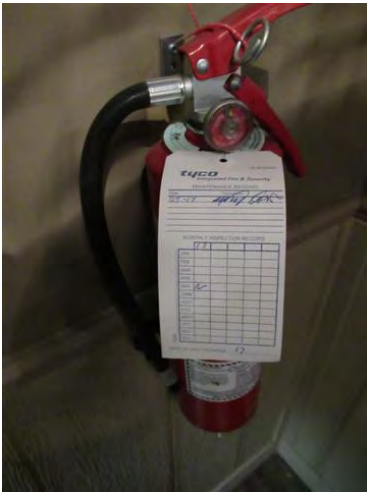
Photo 35

One of several fire extinguishers with an out-of-date inspection certificate

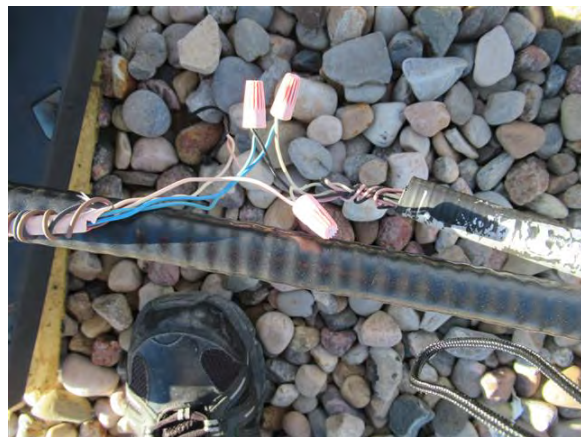
Photo 42
Exposed controls wiring on the roof of the Curling Centre

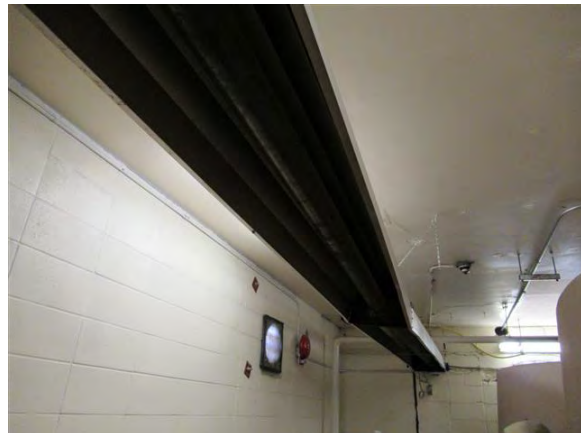
Photo 44
Damaged radiant heater in the old Curling Club refrigeration room

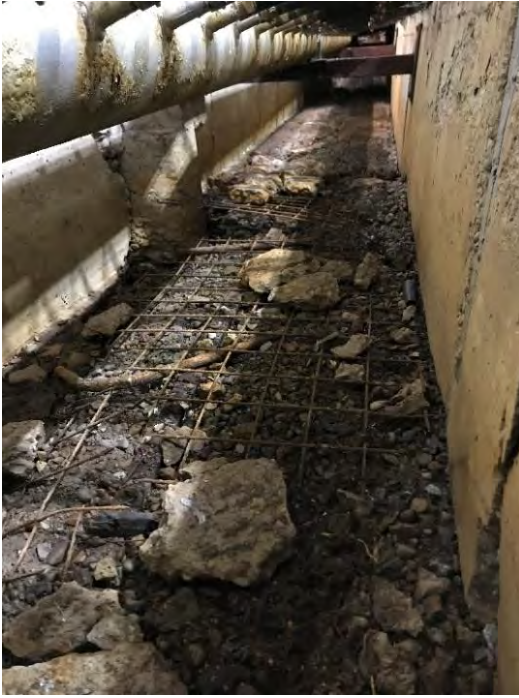
As there was some settlement of the slab measured along the west end of the arena, there is evidence that groundwater may also be contributing to the frost heave of the slab, but this was a much smaller amount of movement. The groundwater level below the Red Dutton Arena was measured between 2.20 m and 1.56m from the finished floor placing it below the anticipated frost penetrations. This is likely because the header trench, with its deteriorated floor, acts as a sump and drains the area and also lowers the general water table.

Photo 1. Red Dutton header trench floor condition

To prevent the frost action from heaving the rink slab, the floor of the header trench will need to be replaced and the walls repaired to create a watertight trench as soon as fiscally possible. But as the header for the slab refrigeration system is located in the trench, replacement of the floor and repair of the walls is nearly impossible without disturbing this piping. Additionally, the cracking caused by the frost heave in the slab has created significant damage to the rink slab, which will only continue to get worse. The slab has been in place for 50 years and has reached its service life and should also be replaced at the same time as the header trench. The condition and service life of the refrigeration system and piping was not assessed as part of this review and considering the condition of the concrete a review of the system is not warranted.

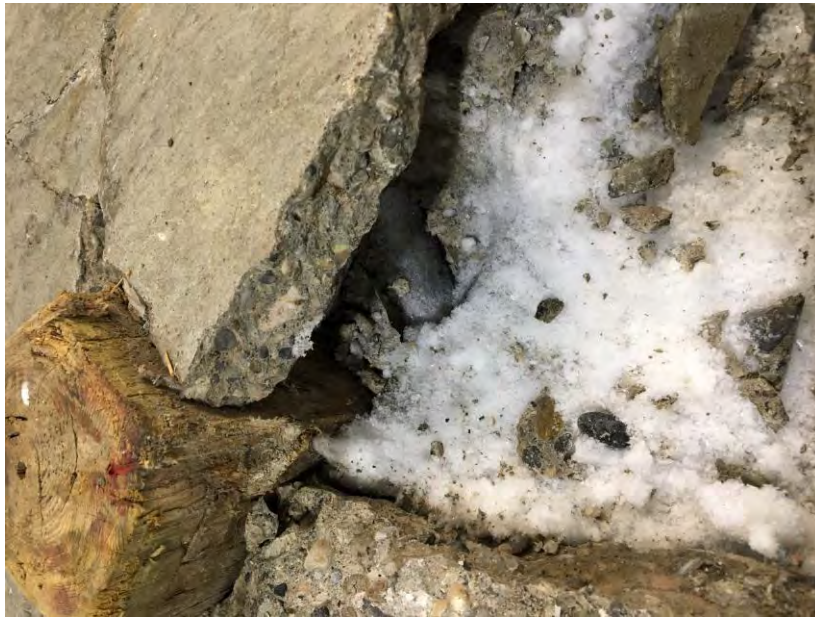
Photo 3. Slab condition and ice formation under slab adjacent to Red Dutton Arena
