RECREATION GOVERNANCE COMMITTEE MEETING AGENDA

ROCKY VIEW COUNTY
RECREATION GOVERNANCE COMMITTEE
July 27, 2020

During the 2019 inspection, the condition of the 1971 Red Dutton Arena concrete floor slabs could not be entirely determined as the ice was in place, but a major crack was observed in the NE corner of the arena. Even so, the *Capital Renewal Plan* determined that the slab would need to be replaced towards the end of the report timeframe (12 years).

As part of the list of projects identified as a priority for the MSI funds, SPFAS engaged MPE Engineering Ltd. to carry out a review of the slab. The primary recommendation provided by this study (Attachment B) is that SPFAS:

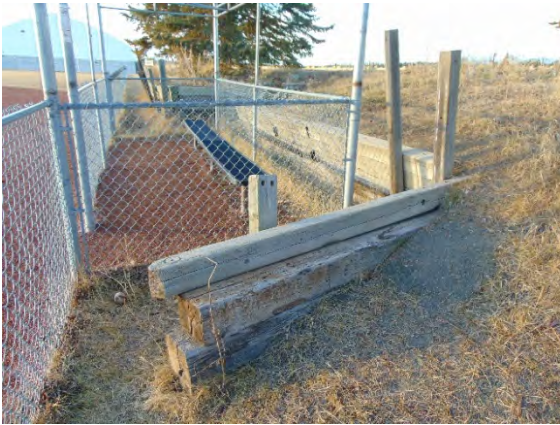
Photo 5
Wood retaining wall at the baseball diamonds to the east of the Main Facility

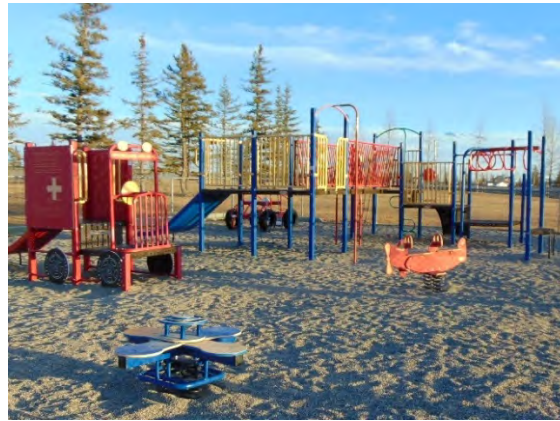
Photo 6
Playground structure to the east of the Main Facility

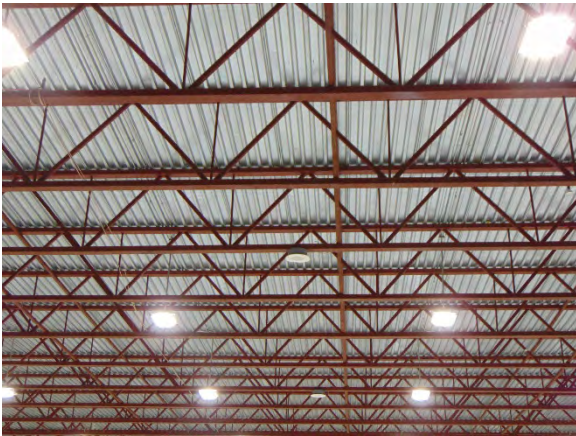
Photo 11
OWSJs in the Shane Homes Curling Rink

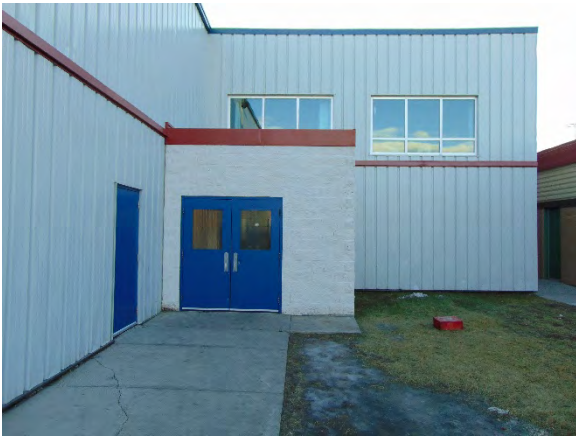
Photo 17
 Typical exterior finishes near the north entrance

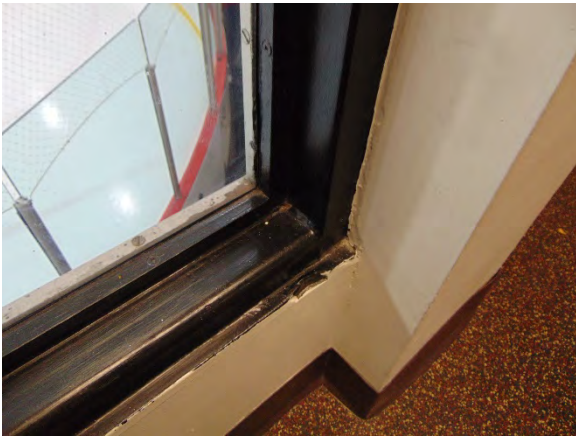
Photo 23
 Interior window detail in the Red Dutton Arena

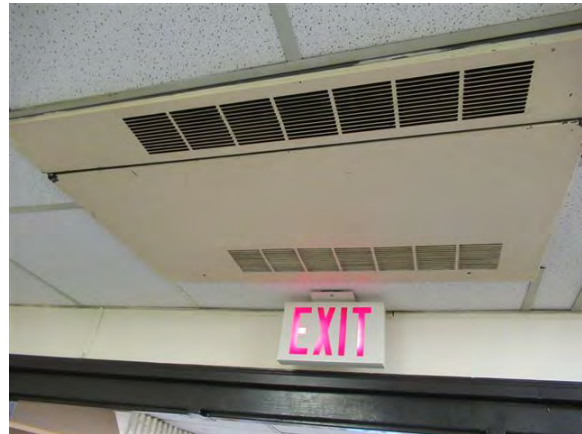
Photo 32

Glycol fed ceiling mounted unit heater in the main hallway

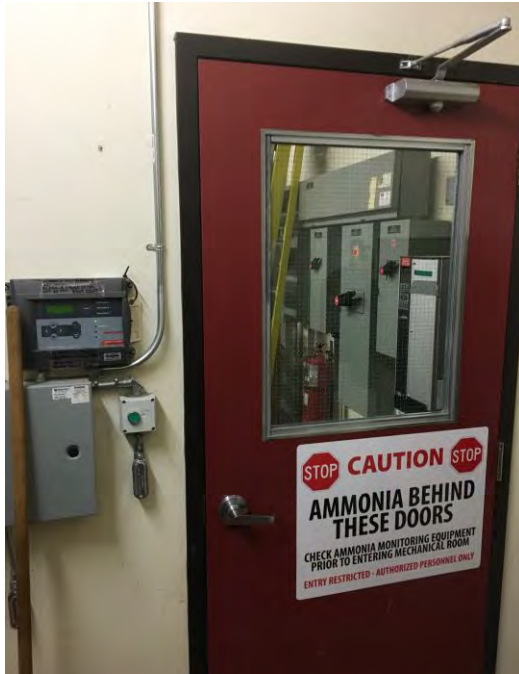
1. Vestibule door with NH₃ detection panel and ventilation fan on switch

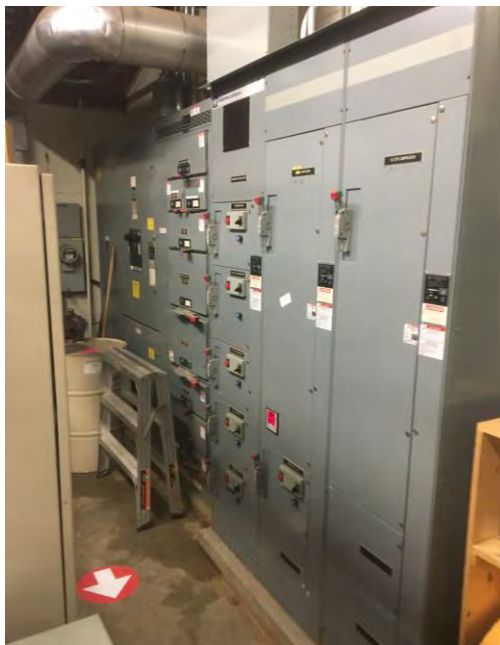
3. Main arena MCC

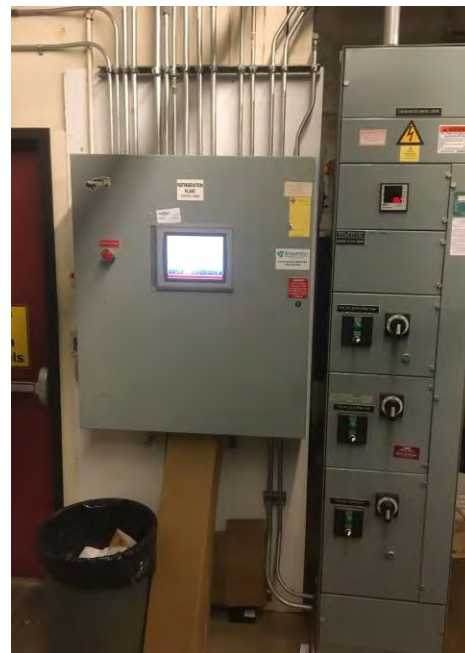
4. Curling MCC and PLC Cabinet

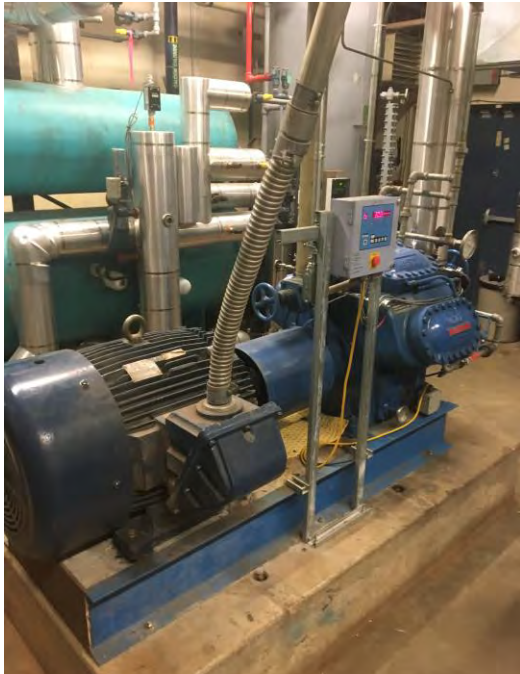
5. Compressor CM-201 showing Mypro temp wiring

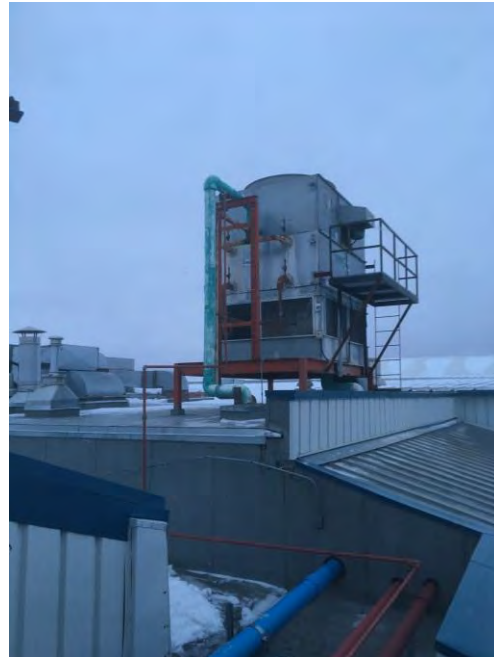
6. CT-201

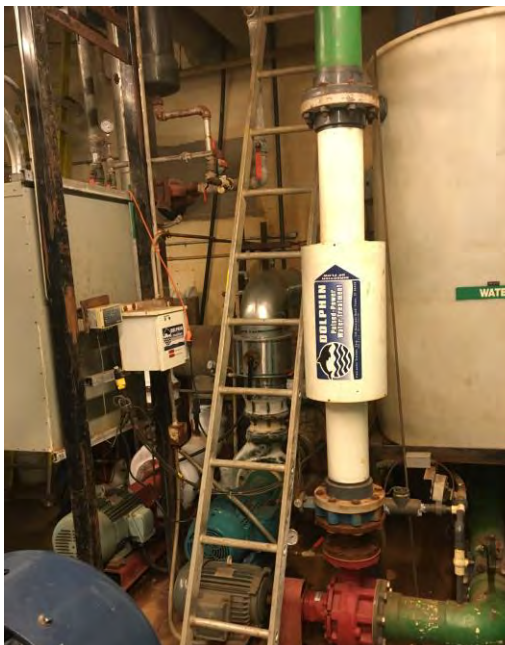
7. Dolphin water treatment, condenser pump and ladder access to expansion tanks

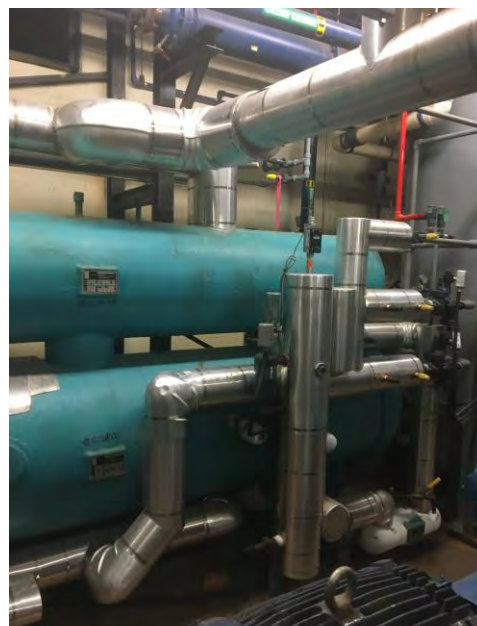
8. CH-101

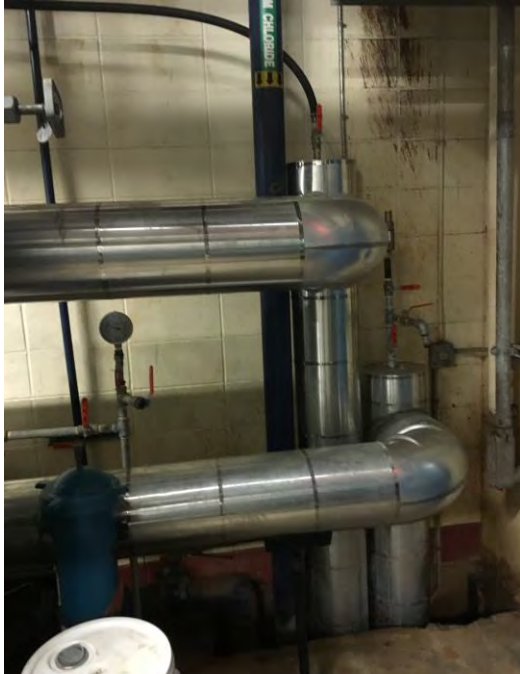
9. New Joe Phillips mains piping

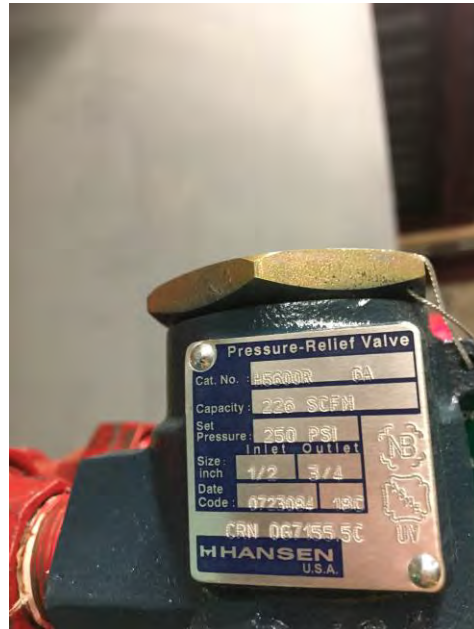
12. New reduced capacity relief valve

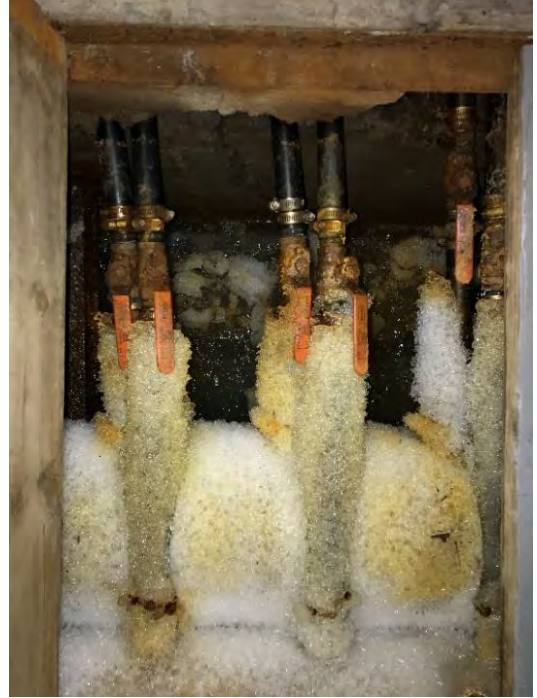
Photo 2. Red Dutton header trench during operation

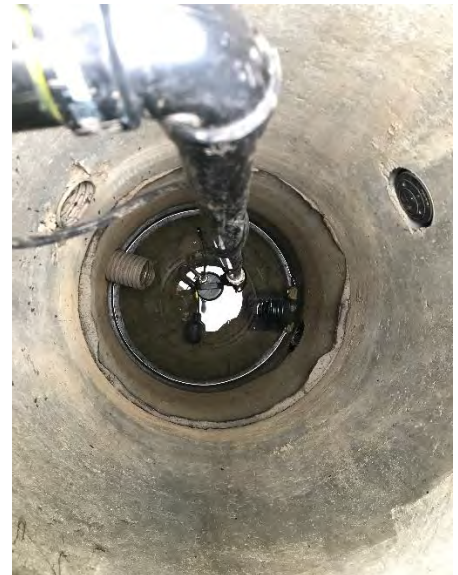
Photo 7. French drain collector sump with pump operational
